Manhole Inspection Summary

Manhole # S13II_026MH

Insp Date: **2/24/09 9:50 AM**

Location Address: **1901 DUKELAND ST**

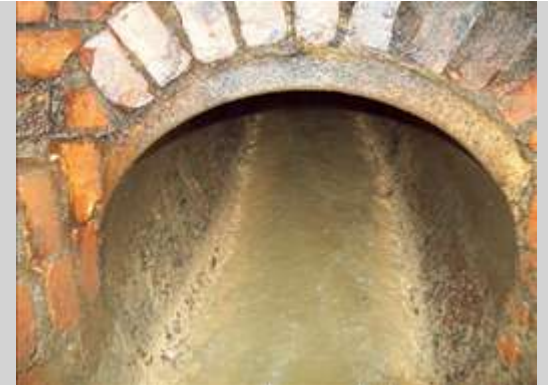
12 O'Clock Outflow

21 in. Circular Gravity Sewer
Pipe Out @ 12 O'Clock

Pipe Height: (in.) Direct
Pipe Material: **Clay** ☐ Pipe Lined
Invert Depth: **31.00** (ft.) Flow Characteristics: **Fast**
Deposits: ☒ None ☐ Mud ☐ Sludge ☐ Debris ☐ Grease
Silt Depth: (in.) Deposits Extent:
Infiltration: **None** Pipe Seal Cond: **Sound**

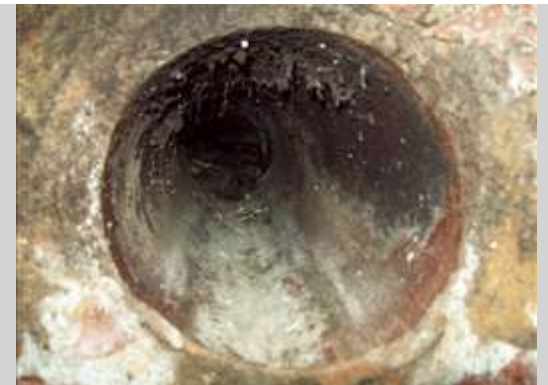
4 O'Clock Inflow

8 in. Circular Gravity Sewer
Pipe In @ 4 O'Clock

Pipe Height: (in.) Direct
Pipe Material: **Clay** ☐ Pipe Lined
Invert Depth: **10.90** (ft.) Flow Characteristics: **Fast**
Deposits: ☒ None ☐ Mud ☐ Sludge ☐ Debris ☐ Grease
Silt Depth: (in.) Deposits Extent:
Infiltration: **None** Pipe Seal Cond: **Sound**

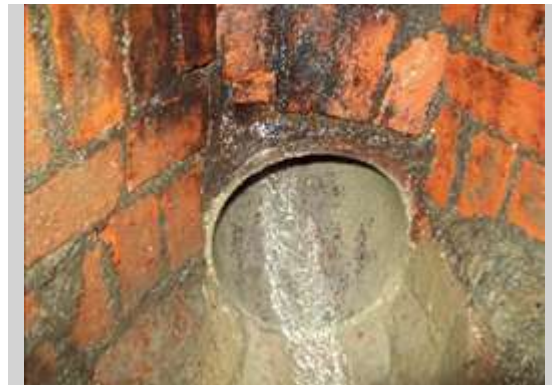
Drop In @ 4 O'Clock

Drop: **Outside Direct**
Angled: Reading: (ft.)
Inv Depth: **30.73** (ft.)
Drop Condition: **Open**

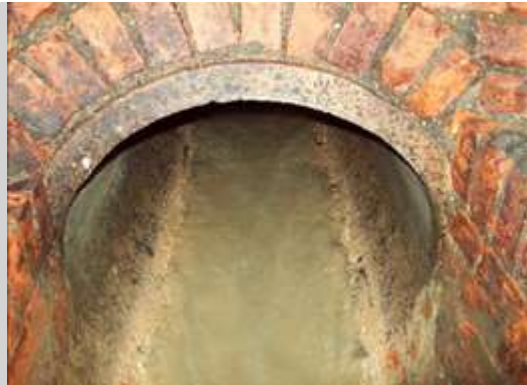
6 O'Clock Inflow

21 in. Circular Gravity Sewer

Pipe In @ 6 O'Clock

Infiltration: **None** Pipe Seal Cond: **Sound**
